Re: **Francis v Wausau Homes Incorporated, et al. – Supplemental Report**
Case No: 5:23-cv-06019

At your request, Christopher Wilkens, P.E. of J.S. Held LLC (J.S. Held) conducted a supplemental evaluation pertaining to the construction of the single-family residential structure located at 31328 Lace Ave., Fairfax, Missouri, 64446. This is a supplemental report, to be used in conjunction with the original report dated January 12, 2022.

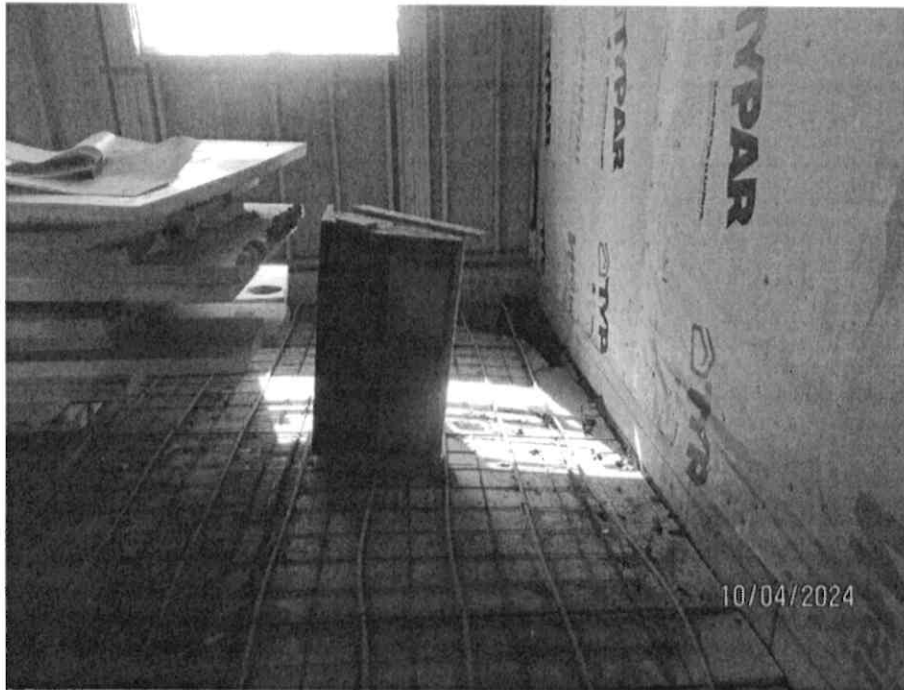
The southwest corner of the garage floor area exhibited a sink hole type of pit within the subgrade, where the rigid foam insulation that had been placed atop the subgrade was sunken downward into the hole. (**Photos 1-3**).

at the base of the basement wall to the elevation of the garage floor. The hole was therefore an indication that the backfill soils were not properly installed in that area, and subsequently underwent consolidation that resulted in lowering top elevation of the fill. This led to the formation of void space between the top of the fill and the underside of the rigid foam slab insulation panels. **Therefore, it was concluded that the sink hole was caused by insufficient preparation of the subgrades within the garage area.**

Photo 1: View of the southwest corner of the garage, showing the "sink hole" area within the subgrade.

A conceptual repair scope for the sink hole issue in the garage would entail the removal and replacement of the fill soils using soil materials and compaction parameters outlined by a design professional.

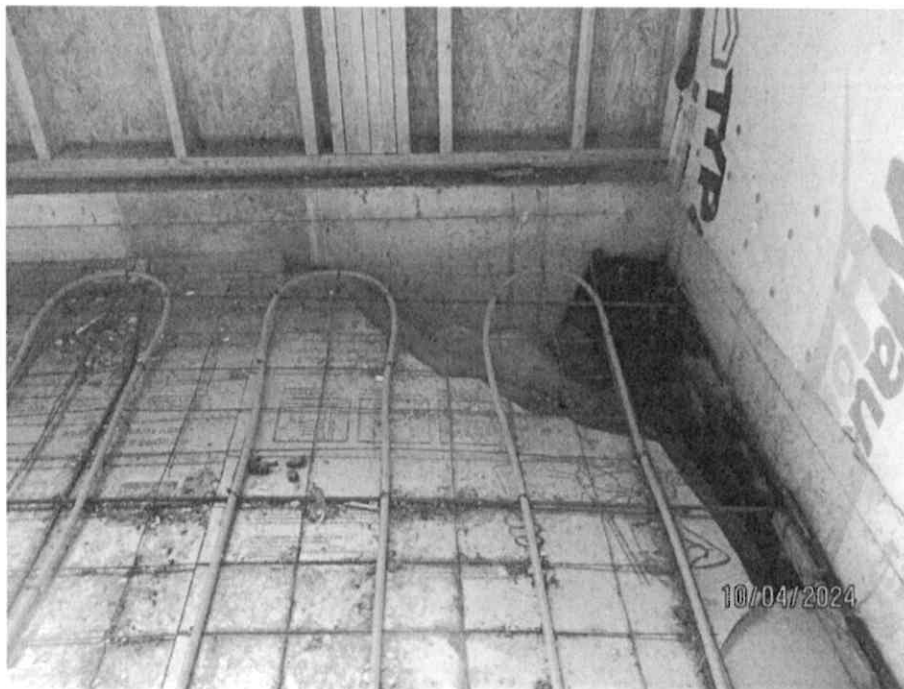
Photo 2: View of the "sink hole" area at the southwest corner of garage; view from north side.

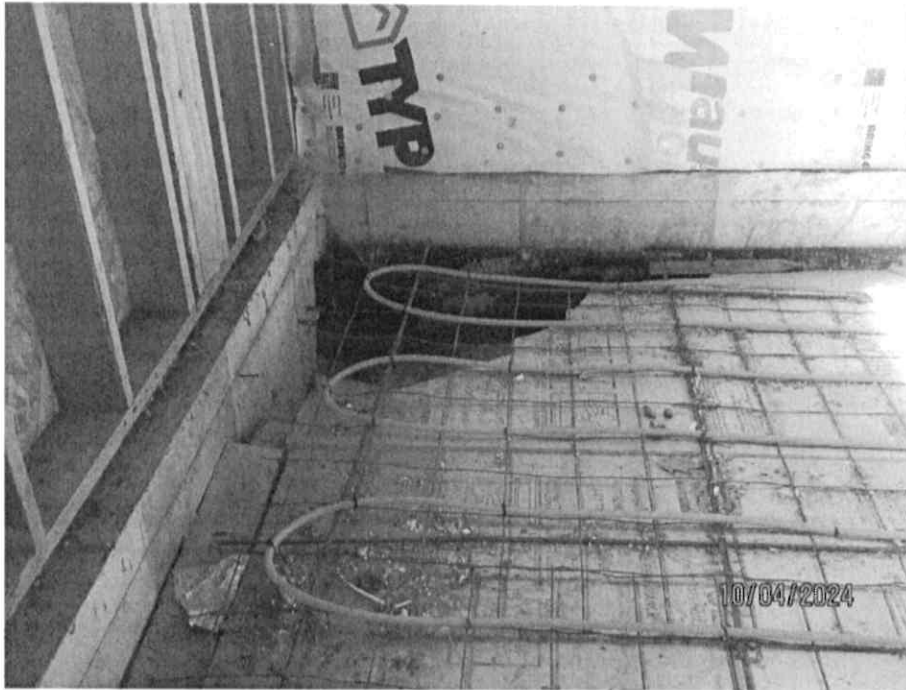
Photo 3: View of the "sink hole" area at the southwest corner of garage; view from east side.

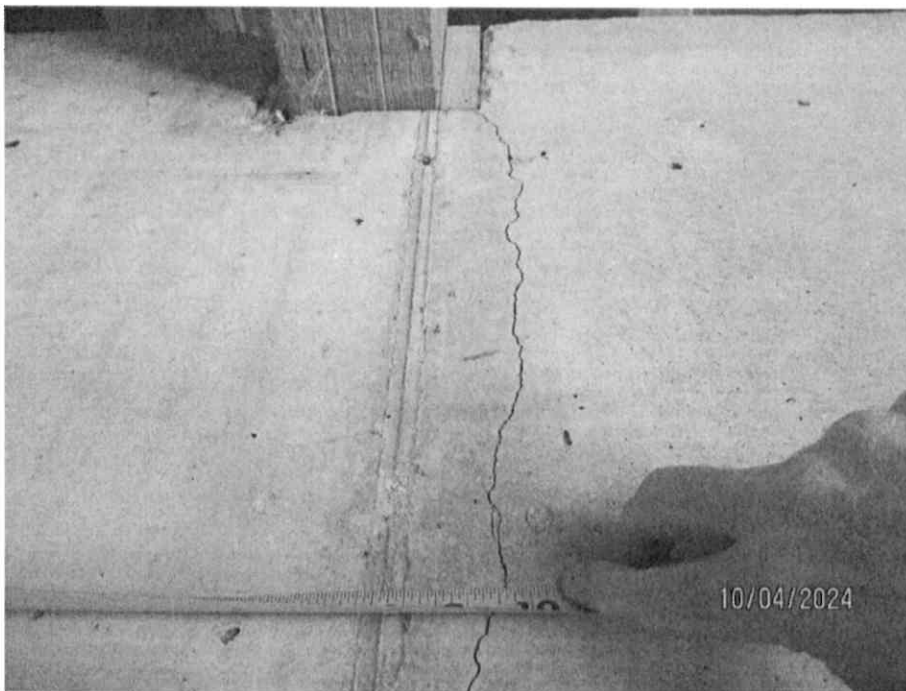
The full-height basement foundation walls (at the west, north, and east sides of the basement) each exhibited concrete cracks located at the approximate mid-lengths of each wall, and that meandered in a generally vertical alignment from the top to bottom of the walls. The widths of the cracks were generally in the range of about 1/32 inches, or about 0.03 inch, in width. The crack on the east foundation wall, however, was narrower toward the base of the wall and widened toward the top of the wall, ranging from hairline to approximately 0.04-inch width. **(Photos 4-8).**

Shrinkage cracks in concrete foundation walls commonly manifest as vertical cracks near the mid-points of a wall length. Shrinkage cracks alone are expected and accepted as normal concrete behavior upon curing. However, normal shrinkage cracks are generally limited to hairline width. American Concrete Institute guidelines state that reasonable crack widths for reinforced concrete under service loads exposed to humidity or soil is 0.012 inches, and for concrete exposed to dry air, 0.016 inches. Approximately 1/64 inches in both cases. Here, the cracks were approximately double to triple of those widths. Larger crack widths can indicate additional issues causing distress beyond normal and accepted concrete shrinkage. Tapered width cracks, as seen at the east wall, are an indication of in-plane rotational and/or shear stress in the wall that can be caused by differential settlements of the foundation into bearing soils. **Therefore, it was concluded that the formation of the concrete wall cracks to widths beyond typical, hairline cracking, was caused by an insufficiency of the foundation or footing construction and/or the bearing soils preparation that led to settlement strains in the concrete.**

Photo 4: View of foundation wall crack at the east basement foundation wall. See next photos.

A conceptual repair scope to reinstate water tightness and continuity at the cracks would entail the installation of patching materials into the cracks. However, it should be noted that continued settlement distresses may be ongoing depending on the severity of bearing soil or footing limitations allowing for movements. A repair scope intended to prevent possible continued movements and crack growth would entail reinforcement of the foundation such as with a retrofit pier system. In the absence of such reinforcement repair, and in the case of continued foundation movements after the completion of the construction, interior finishes would be at risk of future cracking and/or separation damage.

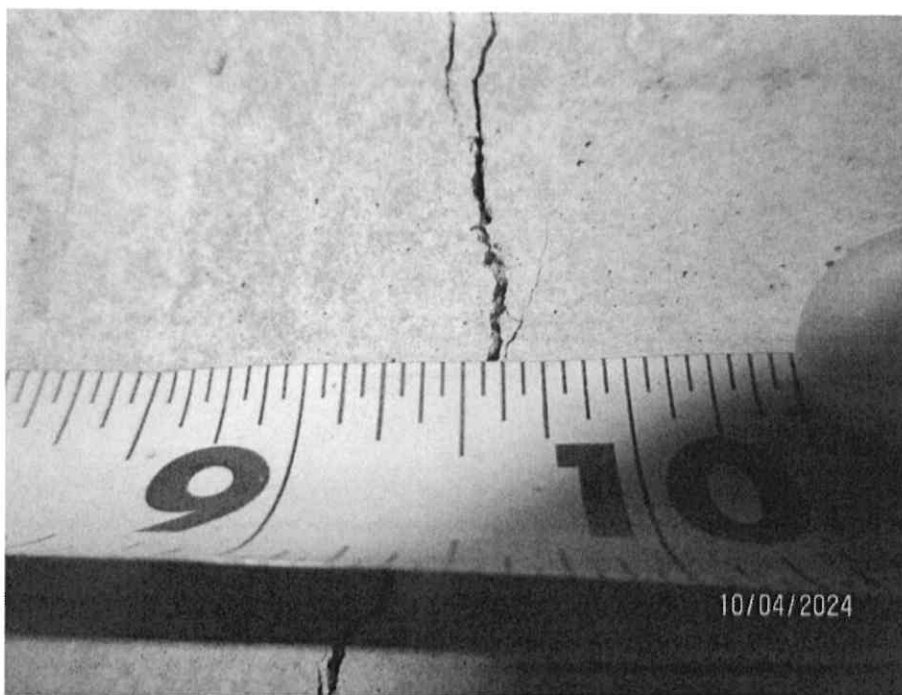
Photo 5: View of east foundation wall crack showing approximately a 0.04-inch (3/64 inch) crack width near the top of the wall.

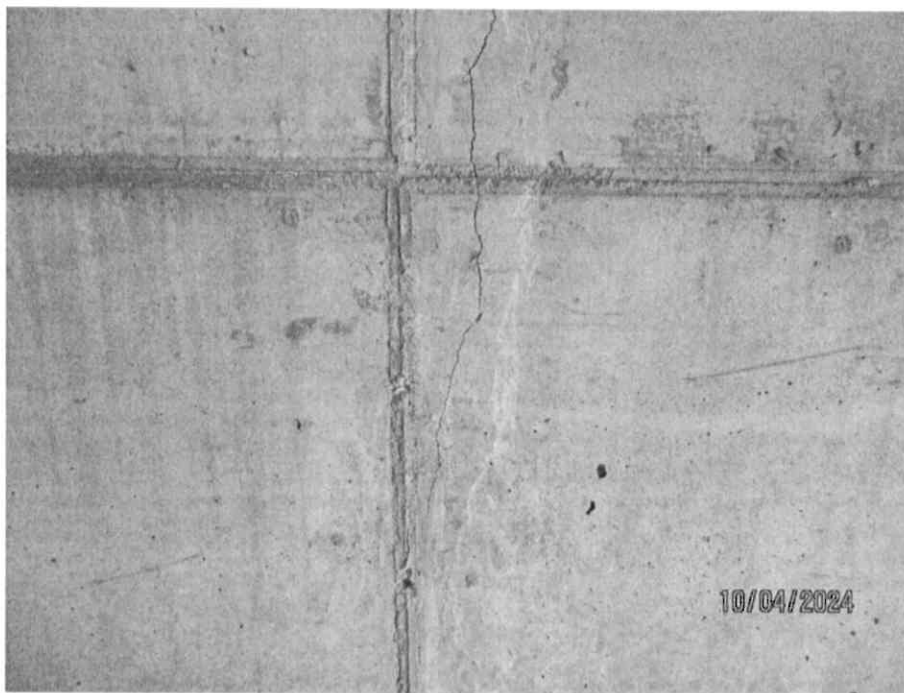
Photo 6: View of crack narrowing in width toward the lower half of the east foundation wall.

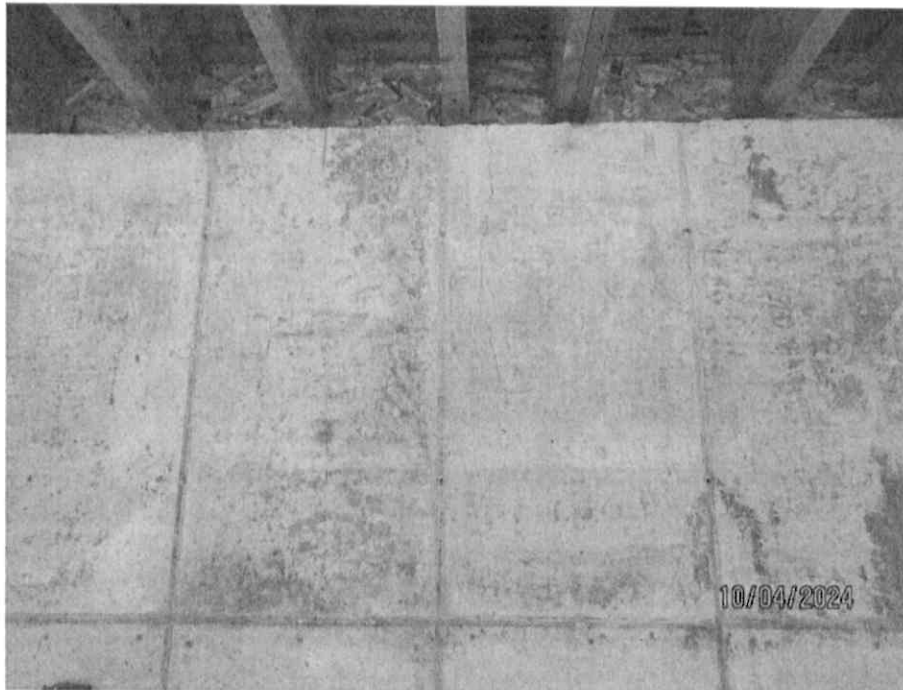
Photo 7: View of foundation wall crack at the north basement foundation wall. See next photo.

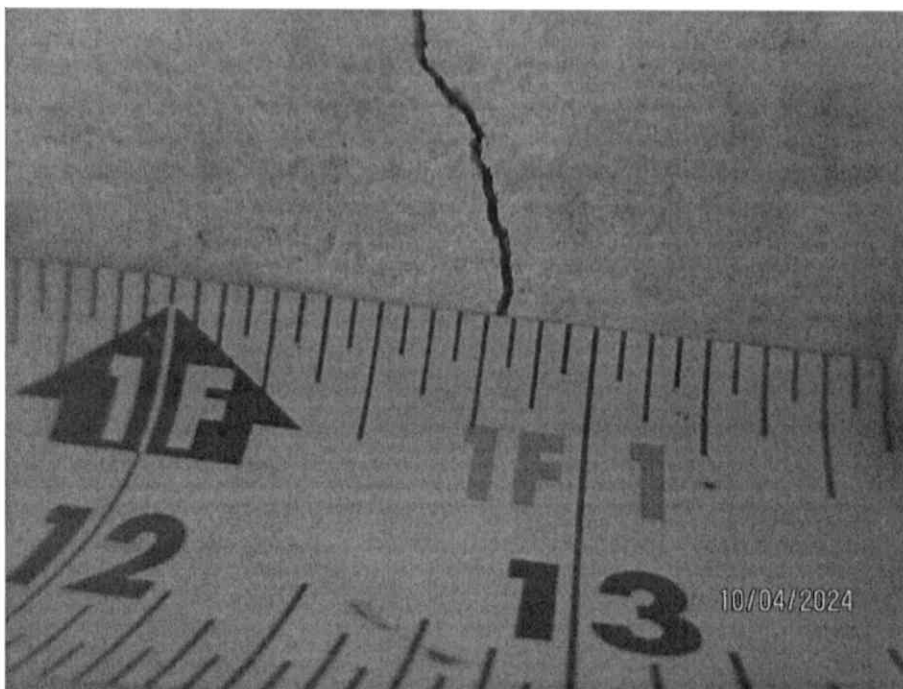
Photo 8: View of north foundation wall crack showing approximately 0.03-inch crack width (1/32 inch).

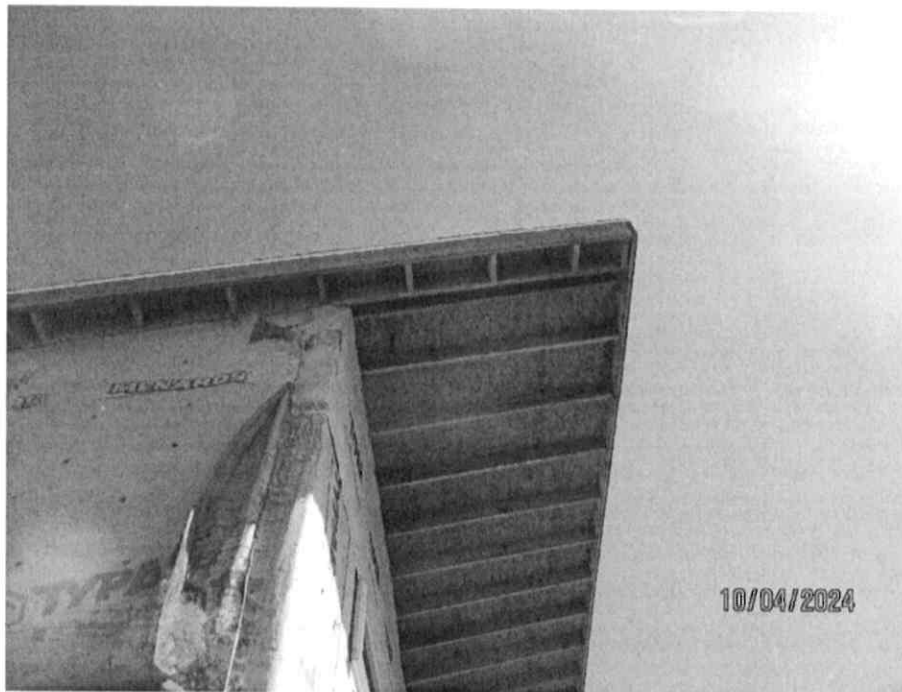
At the southwest and northwest roof corners, the OSB roof sheathing and the adjacent roof joist lumber and rim joist lumber exhibited dark discoloration from moisture exposures emanated on the backsides of the rim joists. **(Photos 9-12).**

Photo 9: View of the southwest corner of the roof. See next photo.

A conceptual repair scope for the roofing items would entail removal and replacement of water damaged rim joists and OSB roof sheathing, scabbing/sistering of reinforcement wood onto water damaged joist overhangs, and reinstallation of the shingle roofing system (including drip edge and underlayment) along the edges and/or the entirety of the roof to properly install and integrate underlayment and drip edge components. However, destructive inspection such as spot removal of shingles would be required to determine the full nature and extent of the roofing installation issues, and the scope of the necessary repairs relating to the roofing installation.

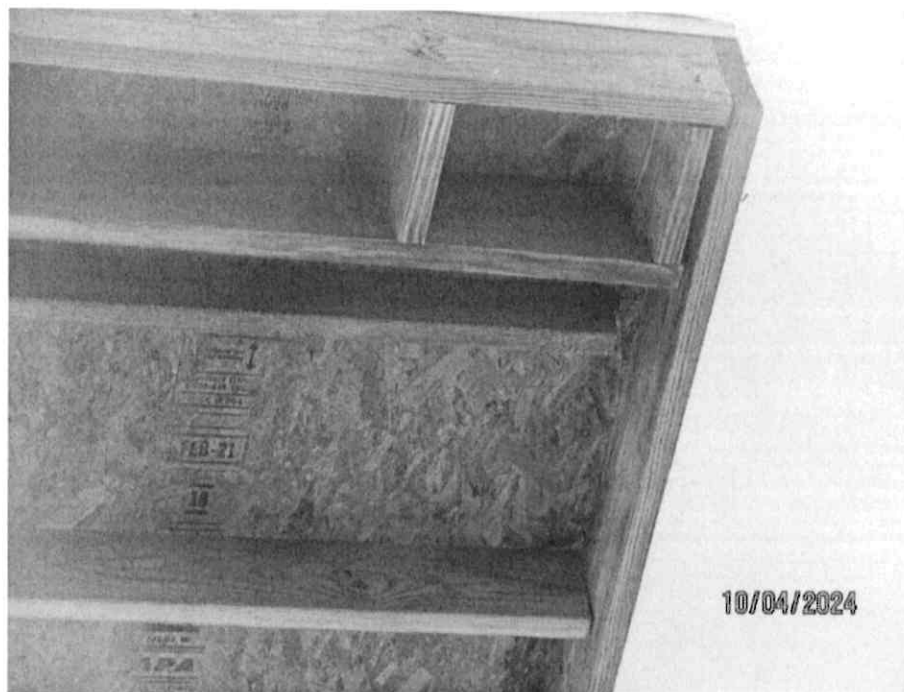
Shingle roof installations utilize metal flashing drip edges at the boundary edges (eave and rake edges) to direct runoff water downward and outward from the roof plane and fascia. The presence of dark discolorations on the wood framing from moisture exposure was an indication that water had migrated through the roof envelope near the location of the drip edges, and therefore indicated a likely incompatibility with the drip edge to underlayment interface, and/or an absence or other issue involving drip edge or underlayment. Such water damage was observed at both the north and south roof eave edges. **Therefore, it was concluded that the water migration and damage was caused by a deficient installation of the shingle roofing system.**

Photo 10: View of southwest corner of roof framing showing dark wood discoloration at OSB roof sheathing, joists, and rim joist.

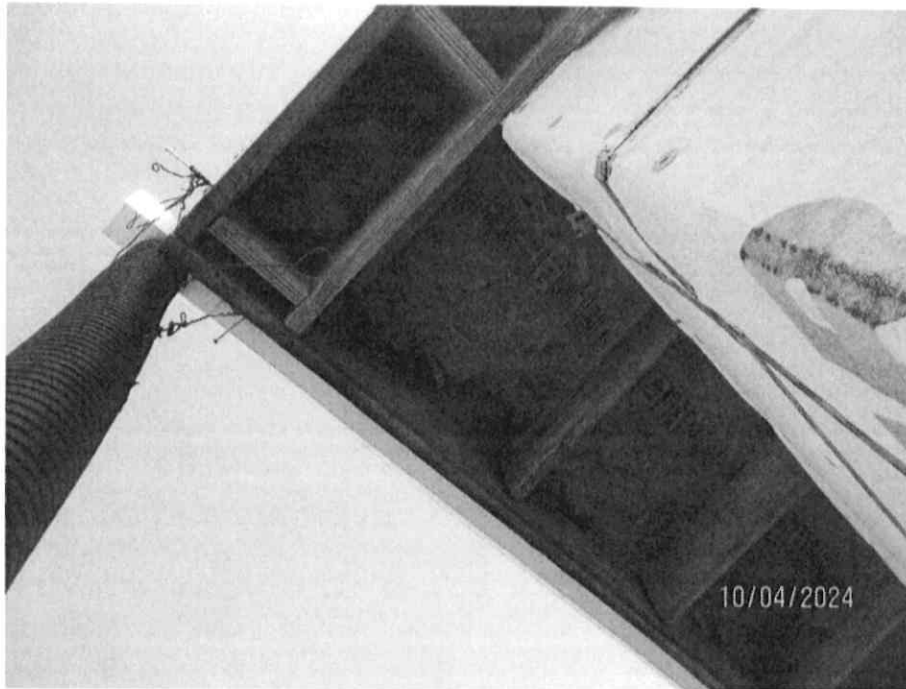
Photo 11: View of the northwest corner of the roof framing. See next photo.

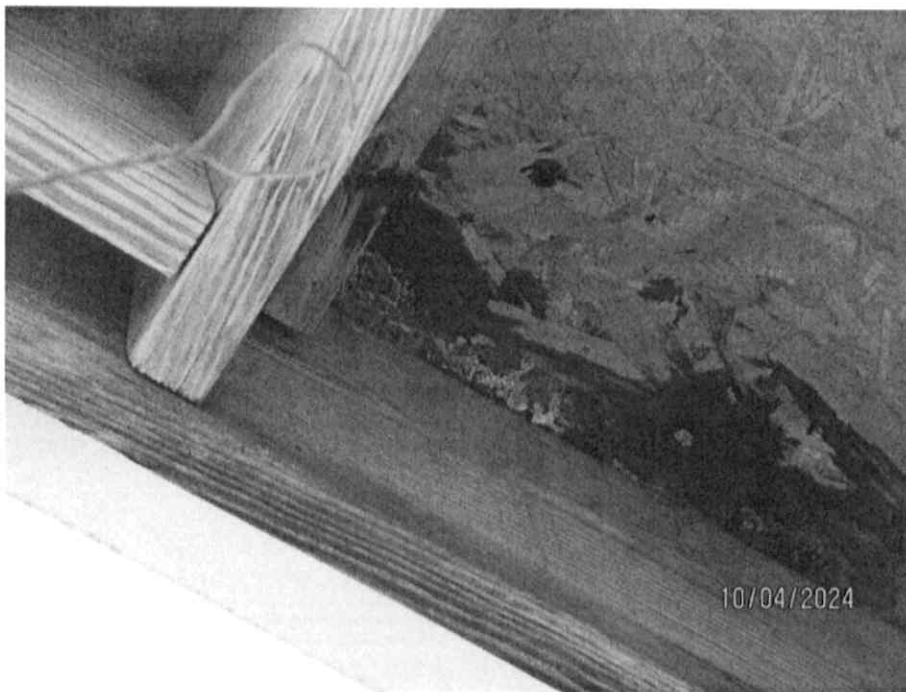
Photo 12: View of northwest corner of roof framing showing dark wood discoloration at OSB roof sheathing, joists, and rim joist.

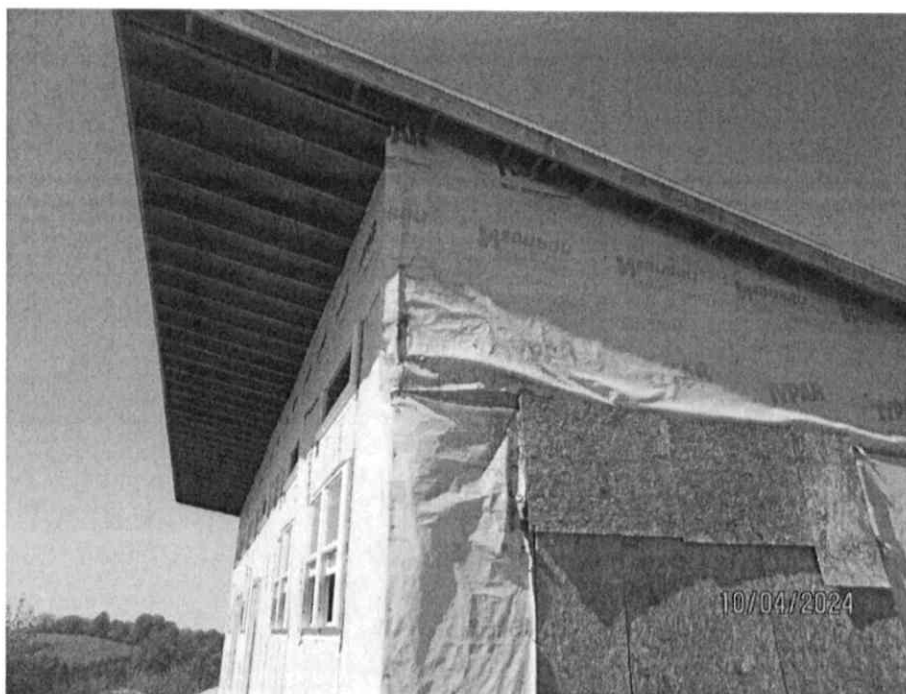
Around all exterior elevations of the residence, the synthetic house-wrap WRB (weather resisting barrier) exhibited varying conditions of tattering, fraying, and detachment. Additionally, at boundary edges of the WRB such as the overhead door openings of the garage and at varying bases or edges of exterior wall framing, the exterior OSB wall sheathing was exposed to the exterior and exhibited dark discoloration and softened wood due to long-term moisture exposure. **(Photos 13-19).**

WRB is an integral component of exterior wall envelopes that is intended to be concealed by the permanent exterior cladding materials, and is not intended to protect the structure from the exterior elements on its own over a long period of time. The observed conditions represented a collective decay of the material due to long-term direct exposure to the exterior environment. This decay led to direct water and sunlight exposure to localized areas of OSB wall sheathing, which in turn caused moisture and UV damage to areas of OSB sheathing. **Therefore, it was concluded that the exterior WRB and localized**

Photo 13: View of detached and displaced exterior WRB areas, as seen on the east elevation and southeast corner. See next photos.

A conceptual scope of repair for the exterior wall damage would entail removal and replacement of all WRB, and select removal and replacement of damaged OSB sheathing panels, followed by the installation of a permanent exterior cladding to appropriately conceal the WRB system. However, the destructive removal of the existing WRB would be required to determine the full extent of OSB damage and replacement scope.

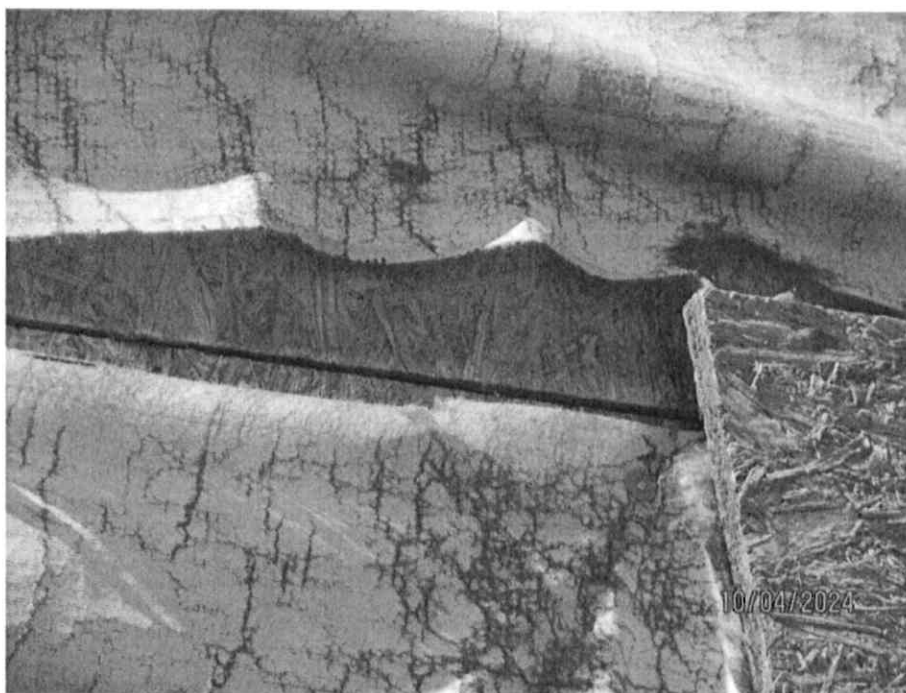
Photo 14: View showing tattered, frayed, detached WRB and water damage to OSB exterior wall sheathing to the south of the overhead garage door on east elevation.

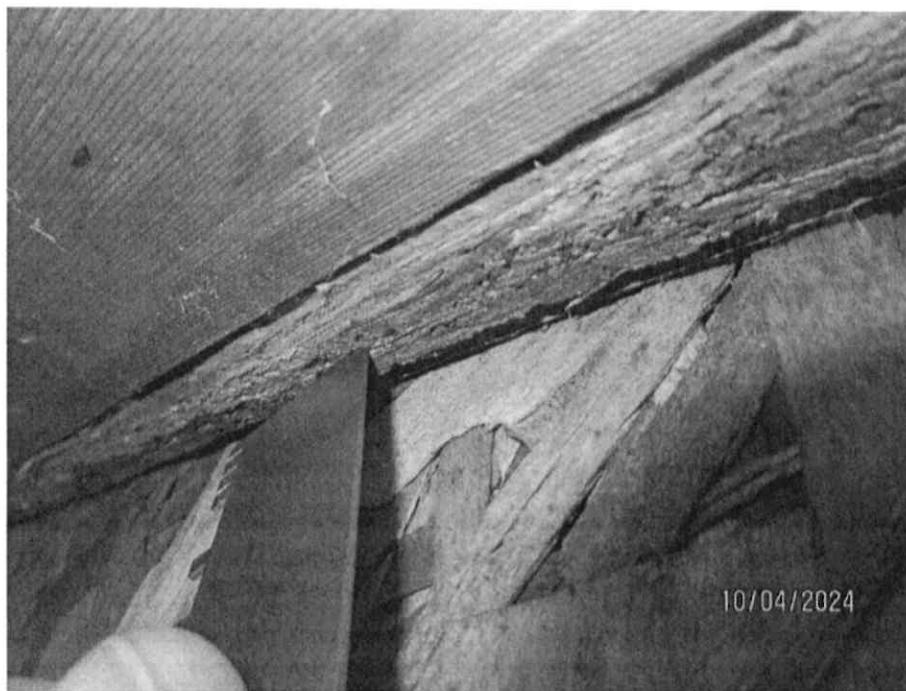
Photo 15: Close-up view showing typical moisture damage to OSB wall sheathing at the tops of the overhead door openings on the east elevation.

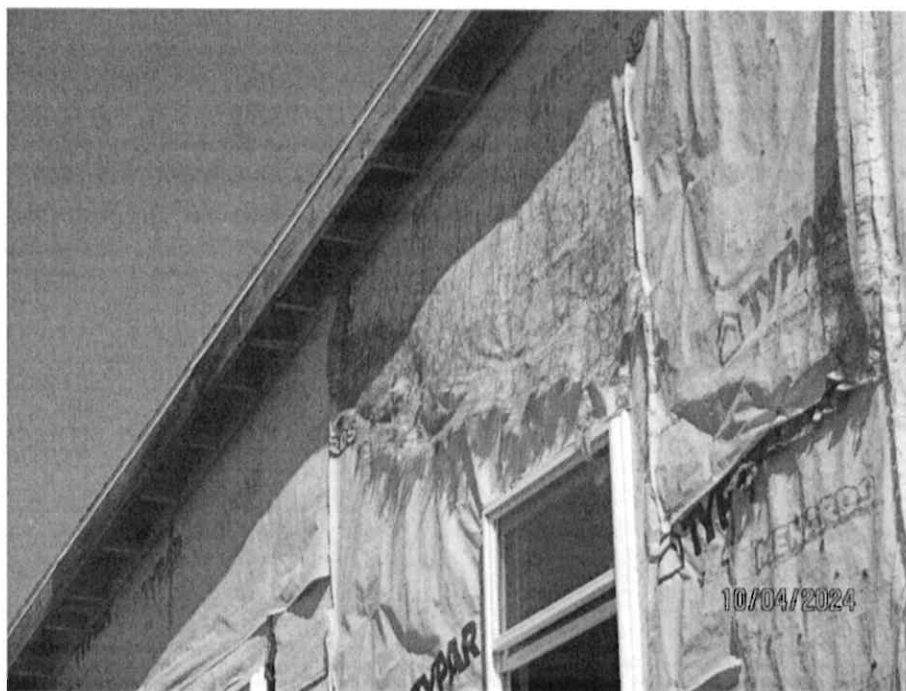
Photo 16: View of tattered, frayed, detached WRB on the west elevation of the residence.

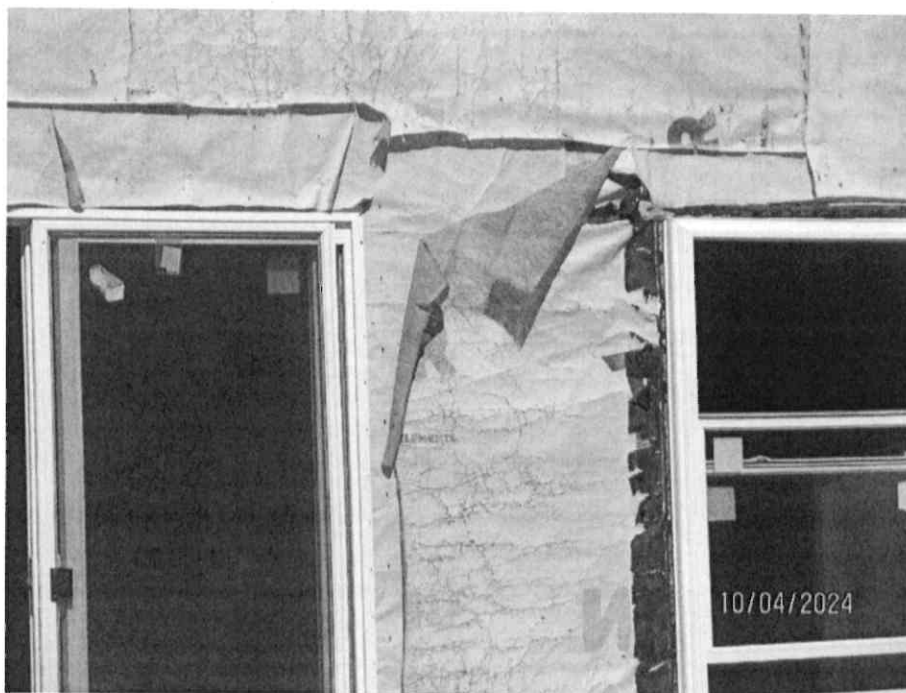
Photo 17: View of tattered, frayed, detached WRB on the south elevation of the residence.

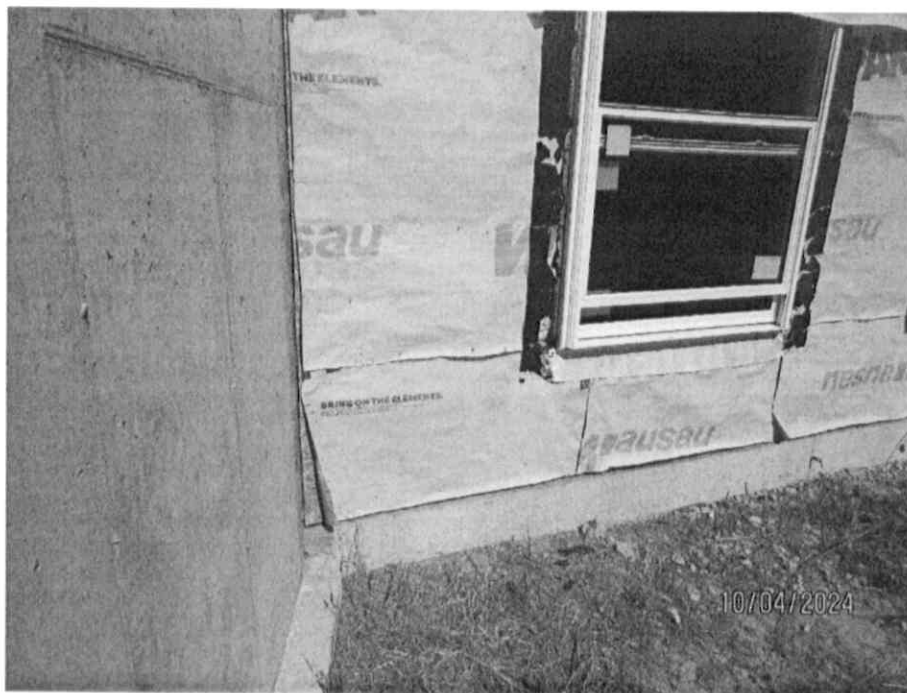
Photo 18: View of tattered, frayed, detached WRB on the south elevation of the residence. See also next photo.

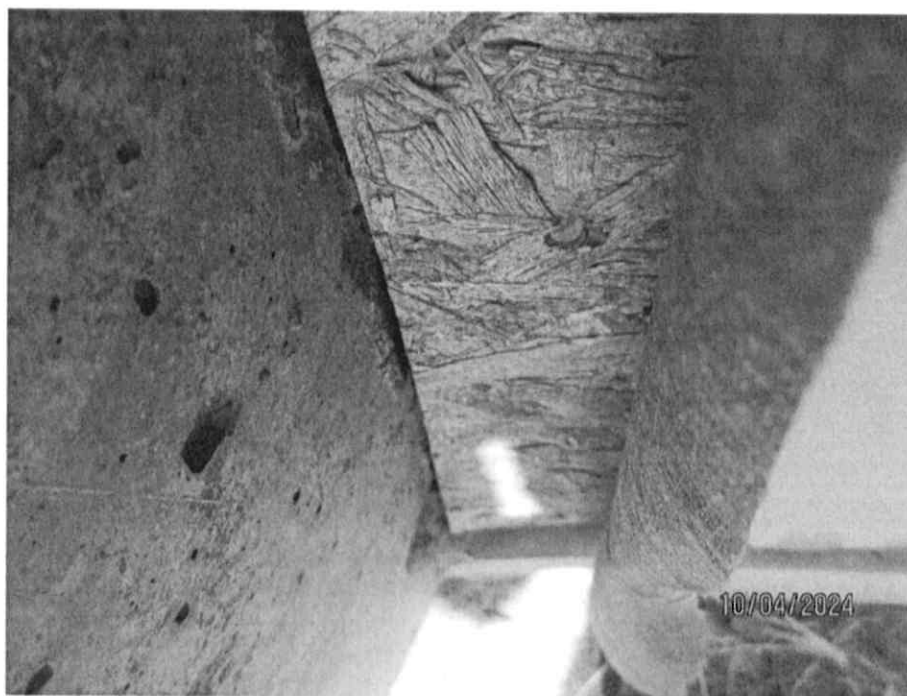
Photo 19: View of moisture damage to OSB exterior wall sheathing at the base of wall at the west end of south elevation.
